Interim Report on the
August 14, 2003
Blackout

January 8, 2004

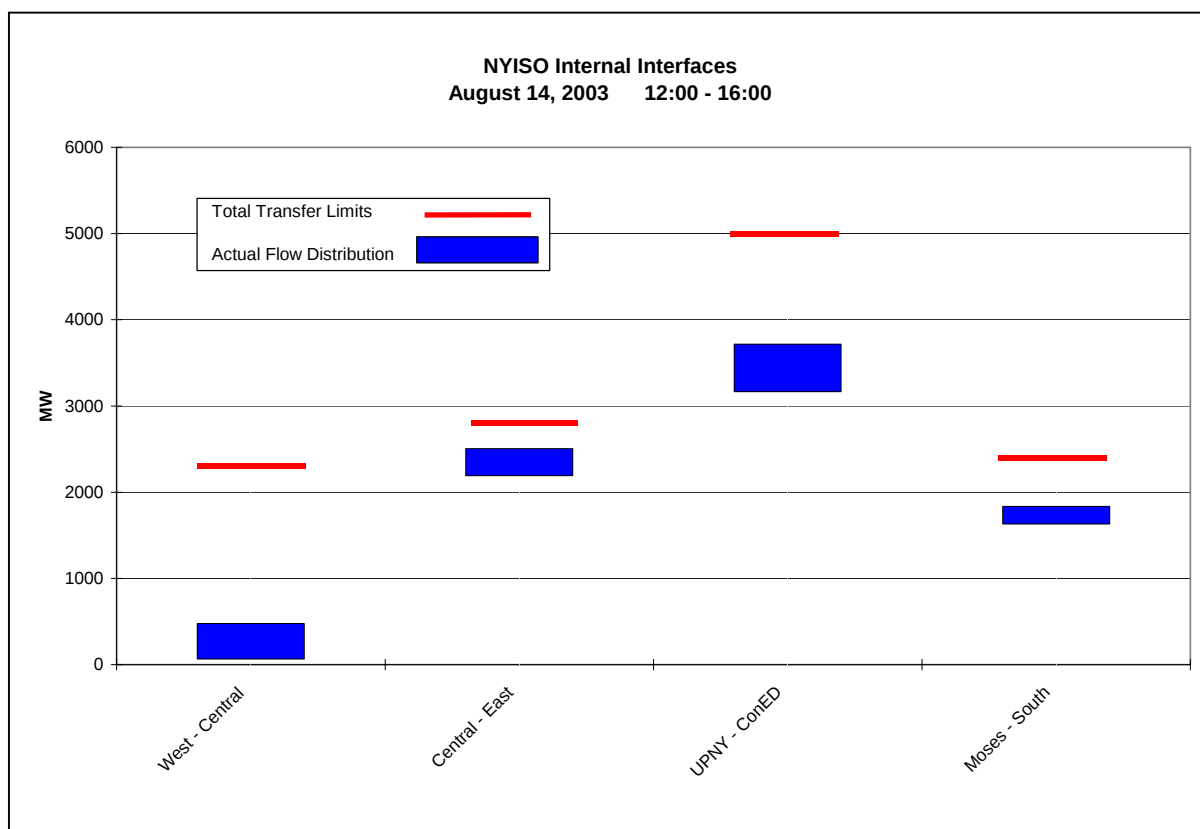
Figure 1.1

Interface flows in the state were typical for a summer day and within secure limits.

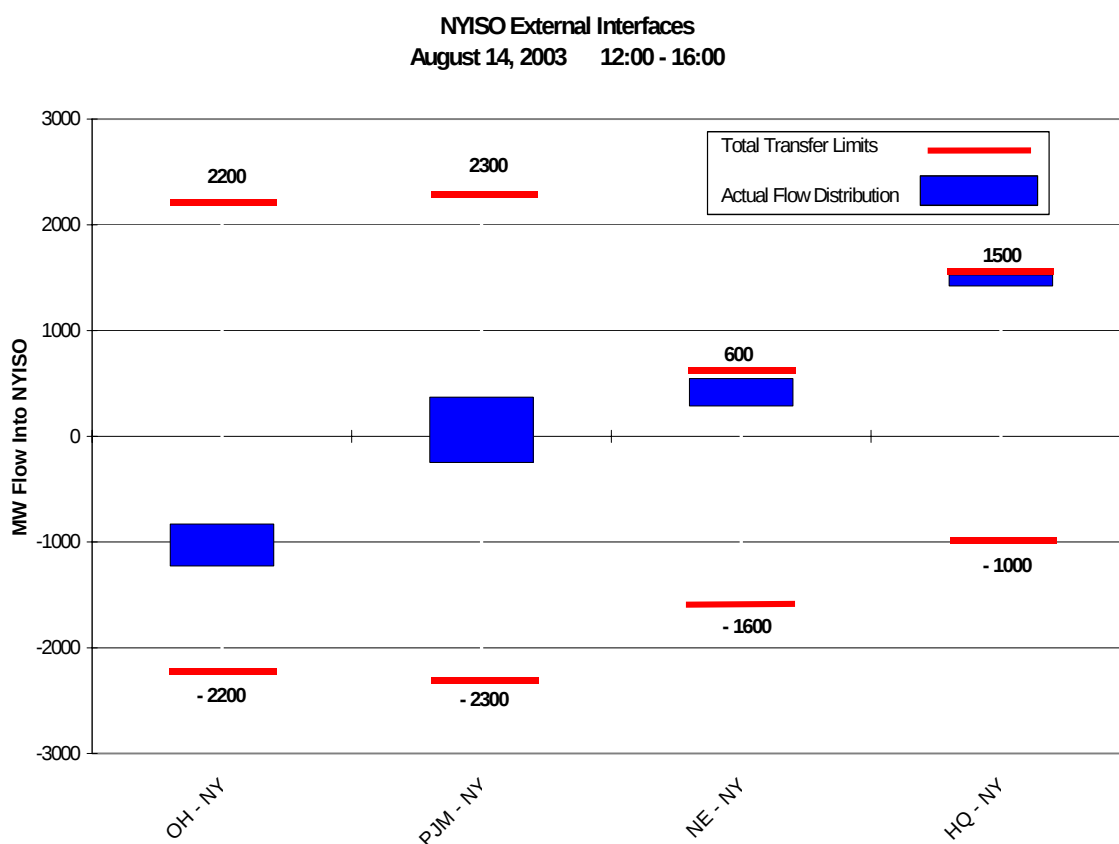
Figure 1.2

New York was importing close to the maximum from New England and Hydro Quebec, there was no Available Transmission Capacity (ATC) remaining on imports from either for most of the day. However, the scheduling on the ISO-NE interface maintains a transfer reliability margin (TRM) of a few hundred megawatts for contingency purposes.

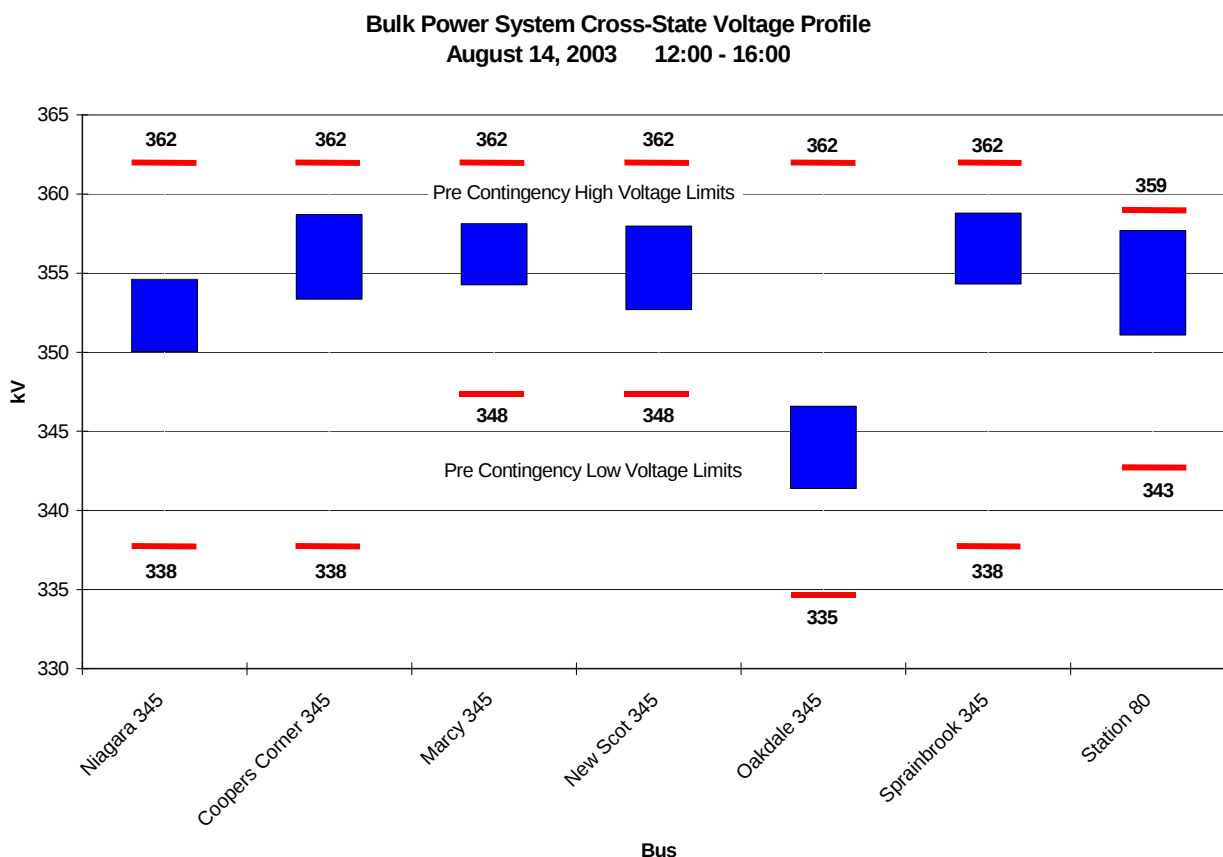
Figure 1.3

Throughout the day, bulk power system voltages were normal.

All monitored station voltages on the 230 kV, 345 kV and 765 kV stations of the bulk power system were within normal operating limits. Voltage limits are established to insure that the worst criteria contingency does not cause the voltages to go below established post contingency voltage limits, typically 95 % of nominal.

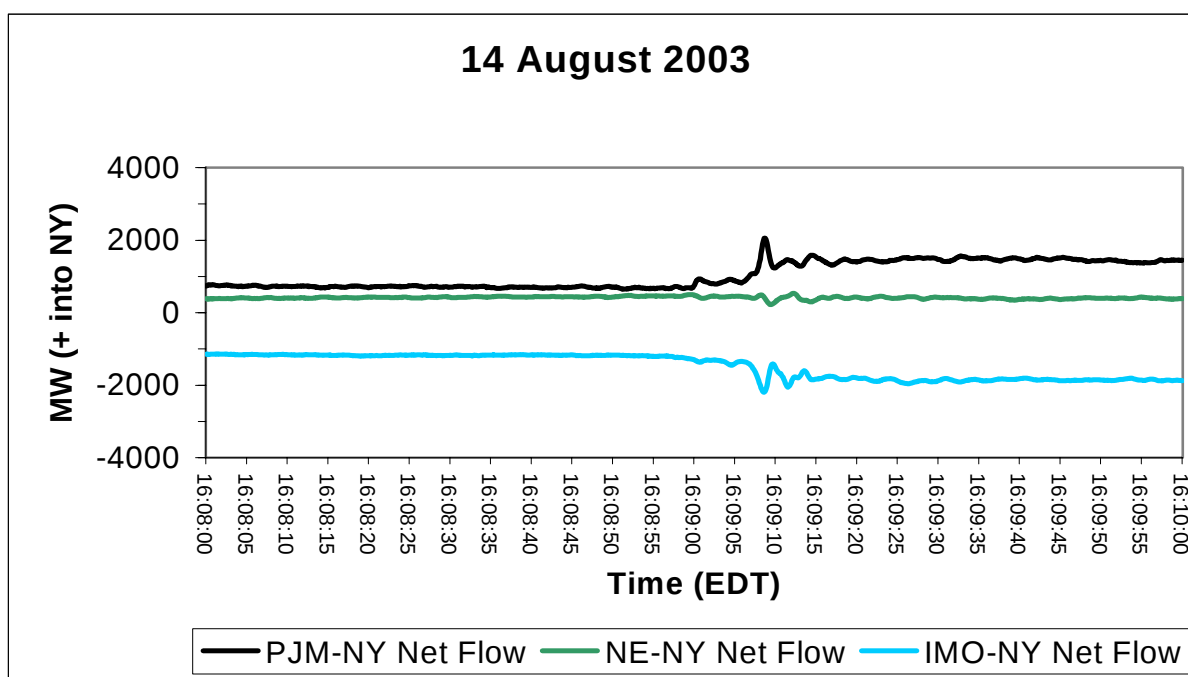
Figure 2.1

When these lines tripped, a large power swing occurred through central Michigan (2,000 MW) and through Pennsylvania, New York (700 MW) and Ontario to supply the FE system. Also during the next 30 seconds, over 900 MW of generation tripped in the Midwest systems (Michigan and Ohio).

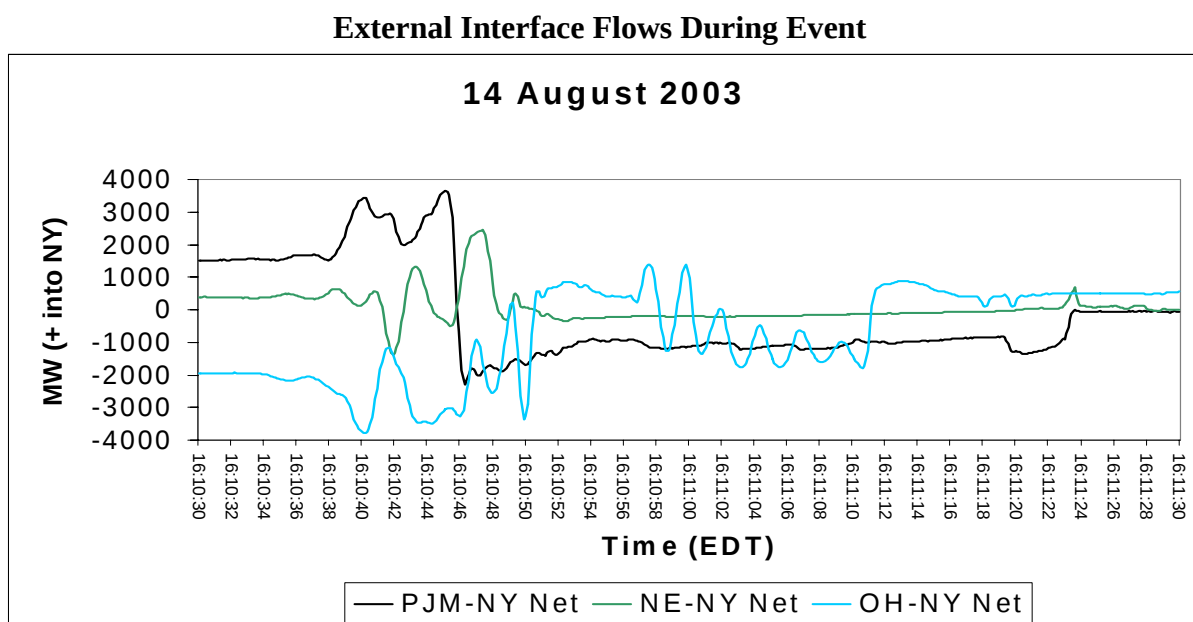
Figure 2.2

When the separation occurred in central Michigan, a very large power swing moved east and north into Pennsylvania and New York and across Ontario in an attempt to serve the loads in southeastern Michigan and northern Ohio.

16:10:38.5 Erie West – Ashtabula 345 kV trips

The separation of parallel 230 kV and numerous 138 kV lines in northern New Jersey completed the separation of PJM and the NYISO and also separated the Rockland Electric and PSE&G northern division from the main PJM system as well. This northeastern part of New Jersey remained connected to the NYISO through the Ramapo – Waldwick 345 kV, and Hudson – Farragut 345 kV circuits. On the initial separation, there appeared to be 2,200 MW of flow into New Jersey on the above ties. In 8 seconds, it quickly drops to 1,100 MW and over the next minute to approximately 450 MW. (Please see figure 2.2)

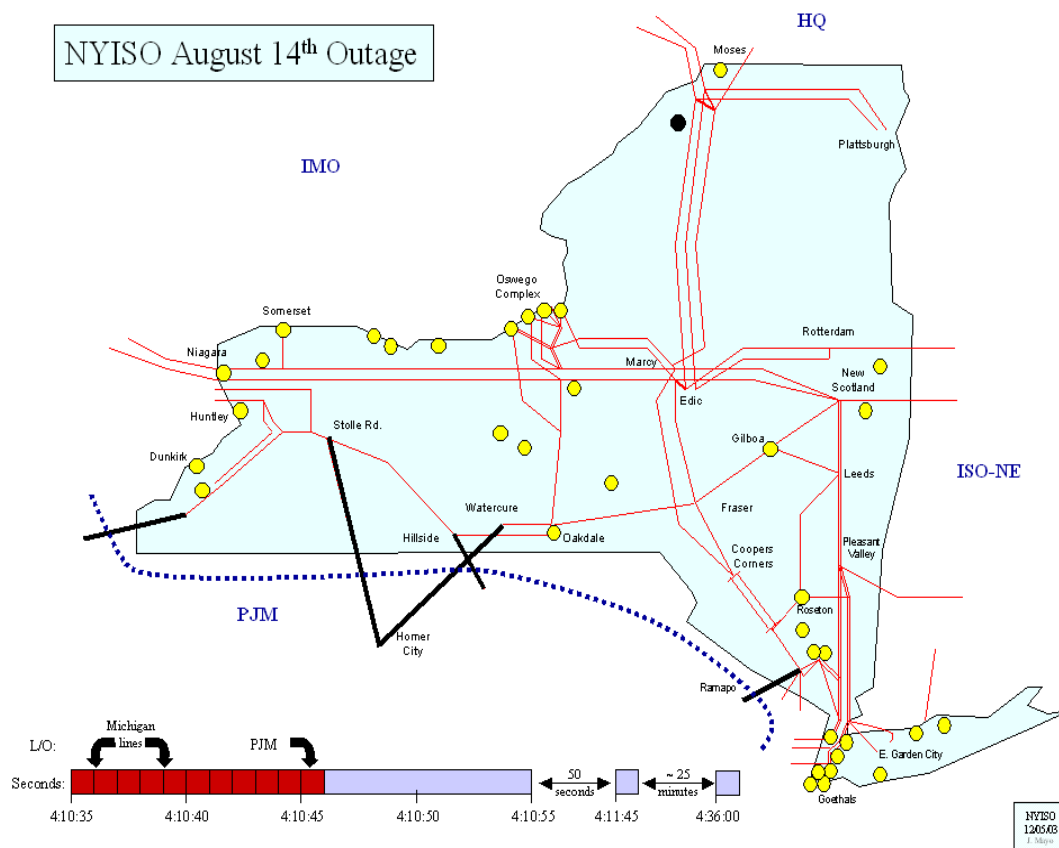
Figure 2.4

The Homer City 345 kV lines to New York, and South Ripley 230 kV tripped due to apparent impedance in zone 1. East Towanda 230 kV indicated apparent impedance in zone 3.

16:10:45.2	Branchburg – Ramapo 500 kV
	Linden – Bayway 230 kV
	Athenia – Cedar Grove 230 kV (2 circuits)

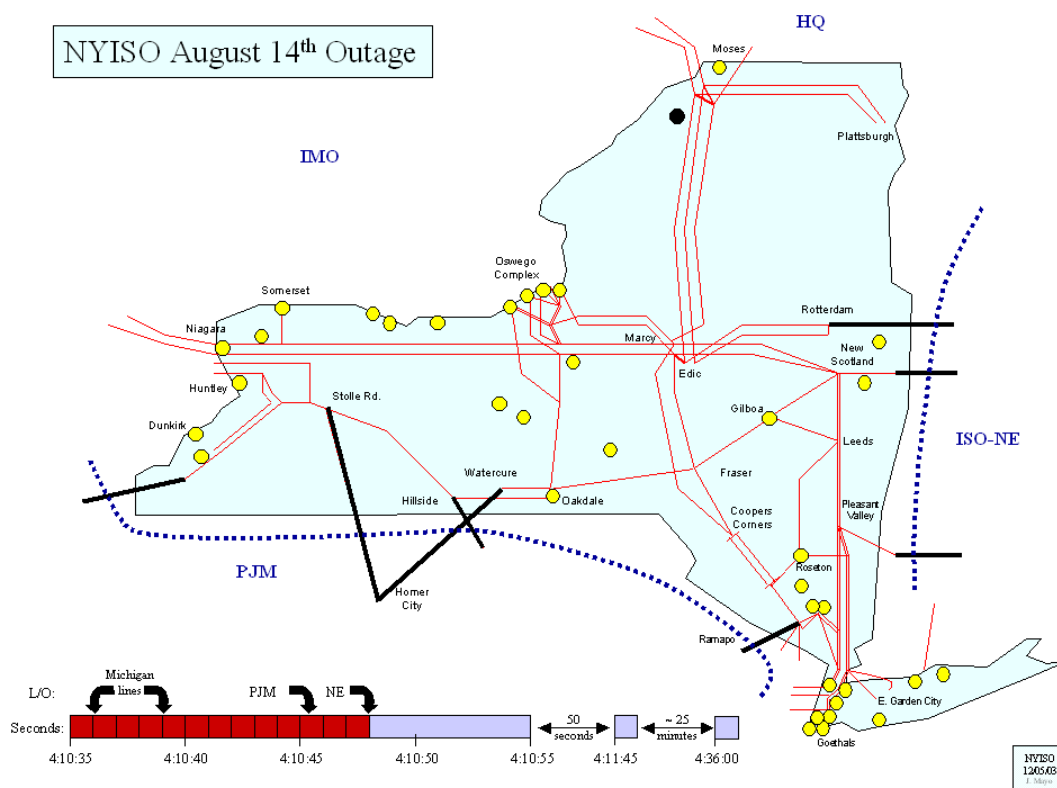
Figure 2.6

At 16:10:46 – 16:10:47 the ties between ISO-NE and New York tripped, and an island was formed including most of the ISO-NE Area and the Canadian Maritime provinces of New Brunswick and Nova Scotia.

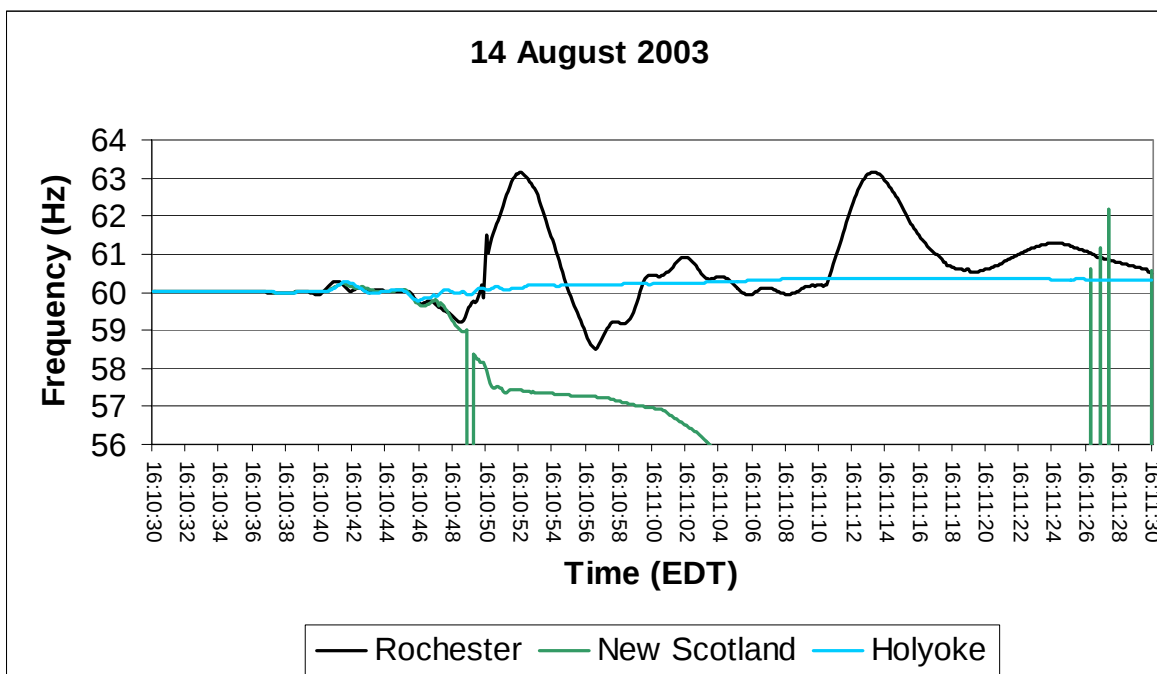
Figure 2.7

Upon separation, the frequency in the large island, consisting of New York, IMO and FirstEnergy, declined rapidly to 59.3 Hz due to the severe generation deficiency in the island (particularly in the Detroit and FirstEnergy areas), and frequency in the New England island recovers toward 60.0 Hz.

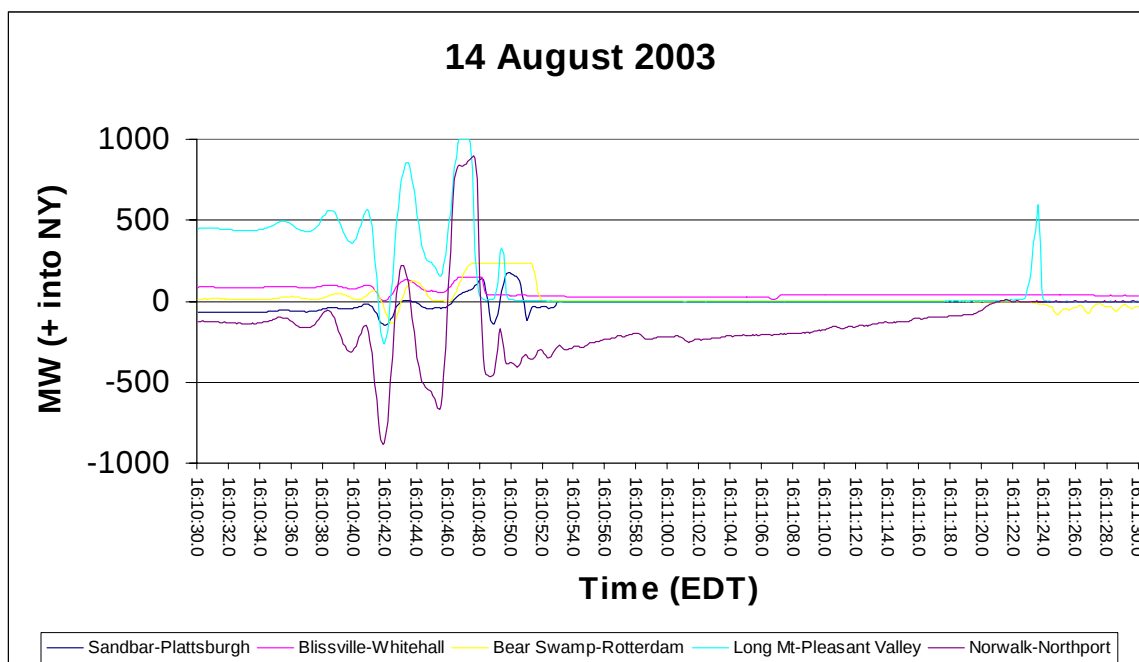
Figure 2.8

- 16:10:46 Rotterdam – Bear Swamp 230 kV
- 16:10:47 Alps – Berkshire – Northfield 345 kV
- 16:10:47 Long Mountain – Frost Bridge 345 kV

Prior to the disturbance, ISO-NE was exporting to the NYISO. This, combined with the power flows toward southwestern Connecticut, caused the Pleasant Valley path to open east of Long Mountain rather than the actual NY-NE tie.

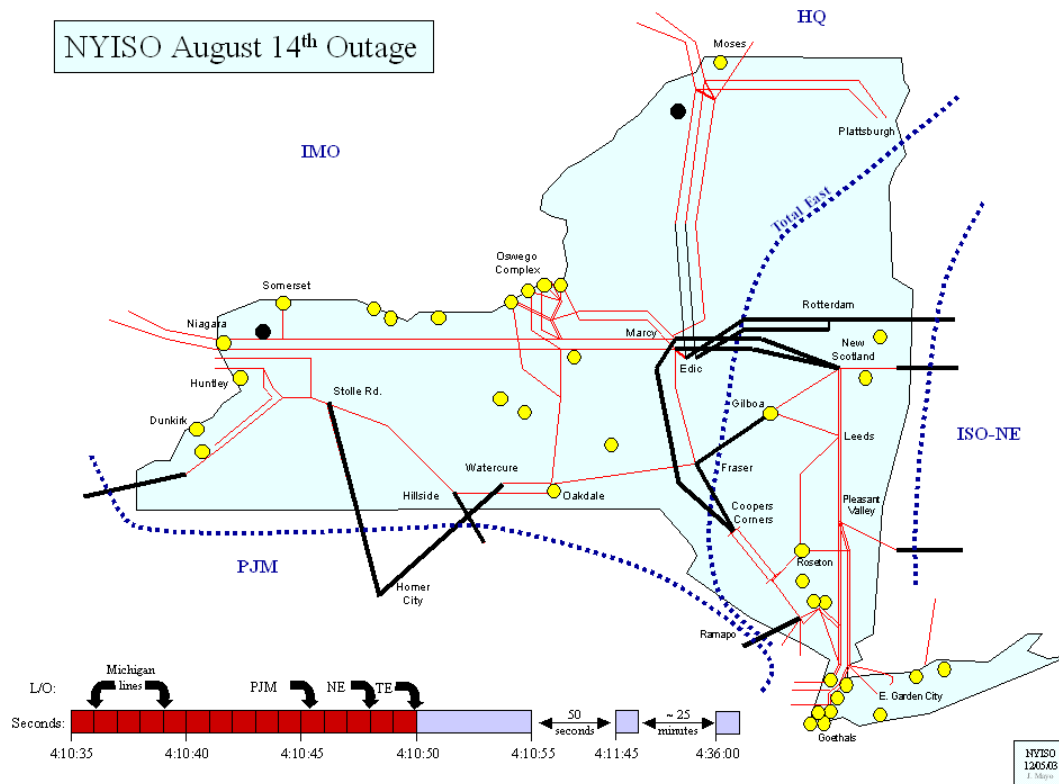
Figure 2.9

- 16:10:48 Marcy – New Scotland 345 kV
Marcy – Coopers Corners 345 kV
Fraser – Gilboa 345 kV
- 16:10:49 Fraser – Coopers Corners 345 kV
- 16:10:49.7 Edin – New Scotland 345 kV
- 16:10:50 Porter – Rotterdam 230 kV (2 circuits)

The result was the effective separation of southeastern New York from the systems to the west. The southeastern New York island, including southwest Connecticut and northeast New Jersey, was severely generation deficient. The frequency declined rapidly through 59.0 Hz and all stages of automatic under frequency load shedding operated in the southeastern island to disconnect 7,115 MW load by 16:10:54.

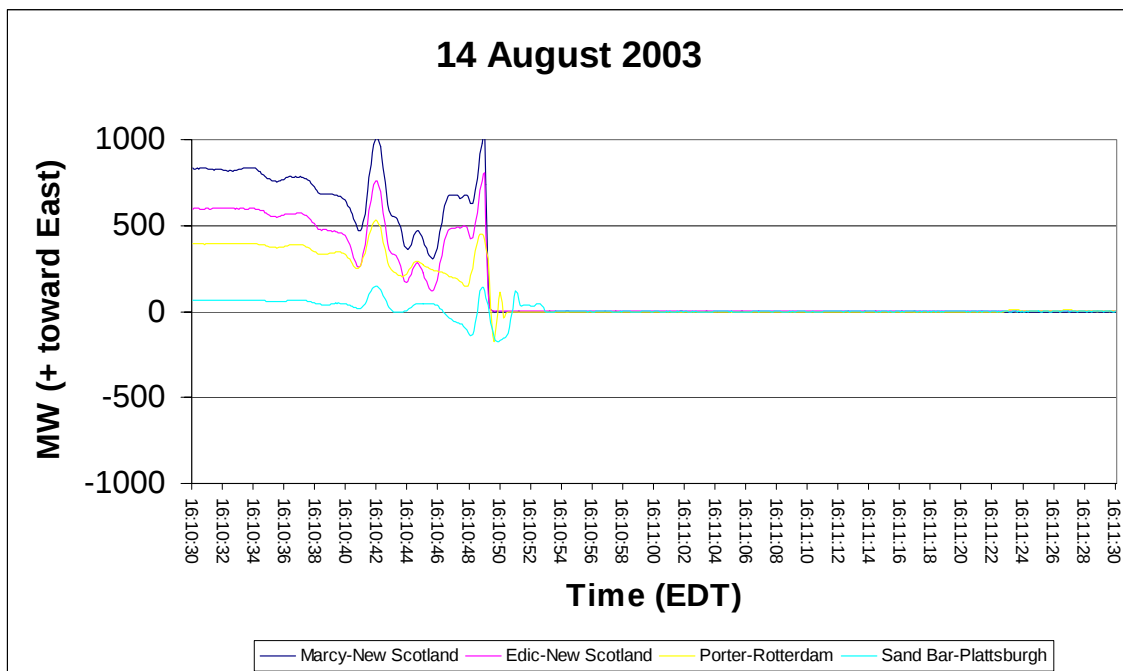
Figure 2.10

Central East Ties During Event

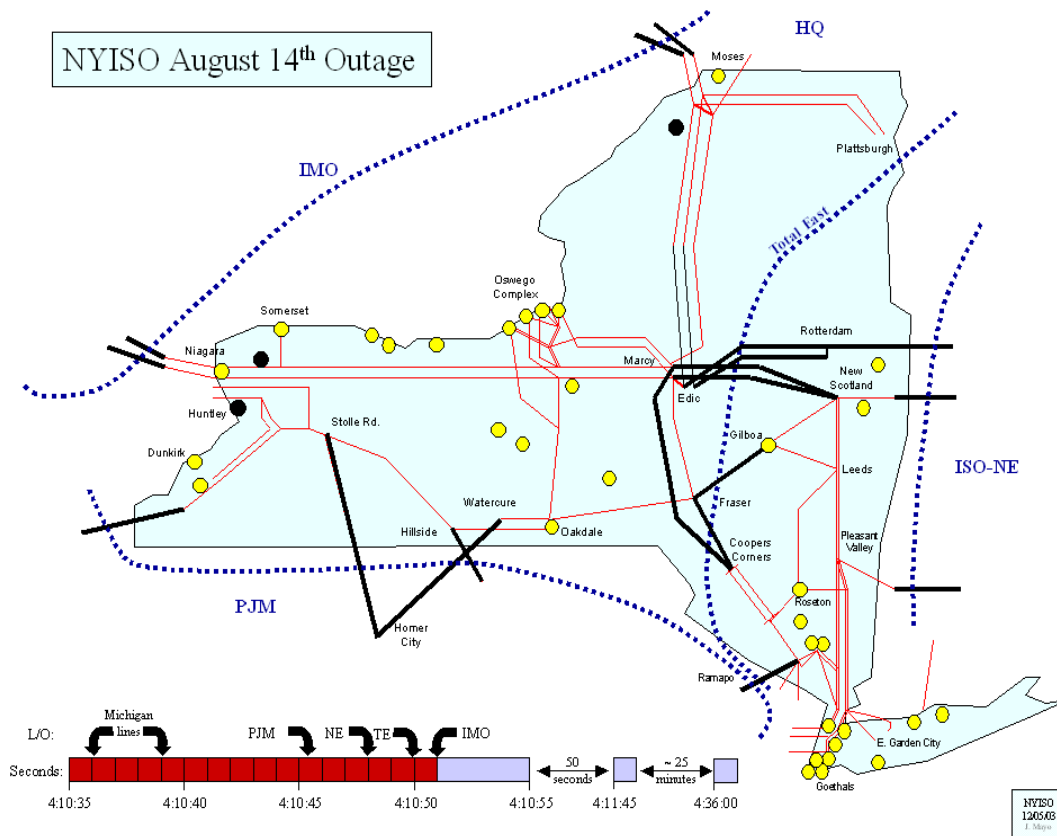
Figure 2.11

- 16:10:49.4 St. Lawrence – Hinchinbrooke 230 kV (2 circuits)
St. Lawrence – Albion 230 kV
- 16:10:49.8 Middleport – Hamilton – Beck 230 kV (5 circuits)

When the separation occurred, a new island formed including New York (west of Total East), the Ontario Beck and Saunders generation and the Niagara Falls (Ontario) load. This island was generation rich, and the frequency rose to 63.2 Hz.

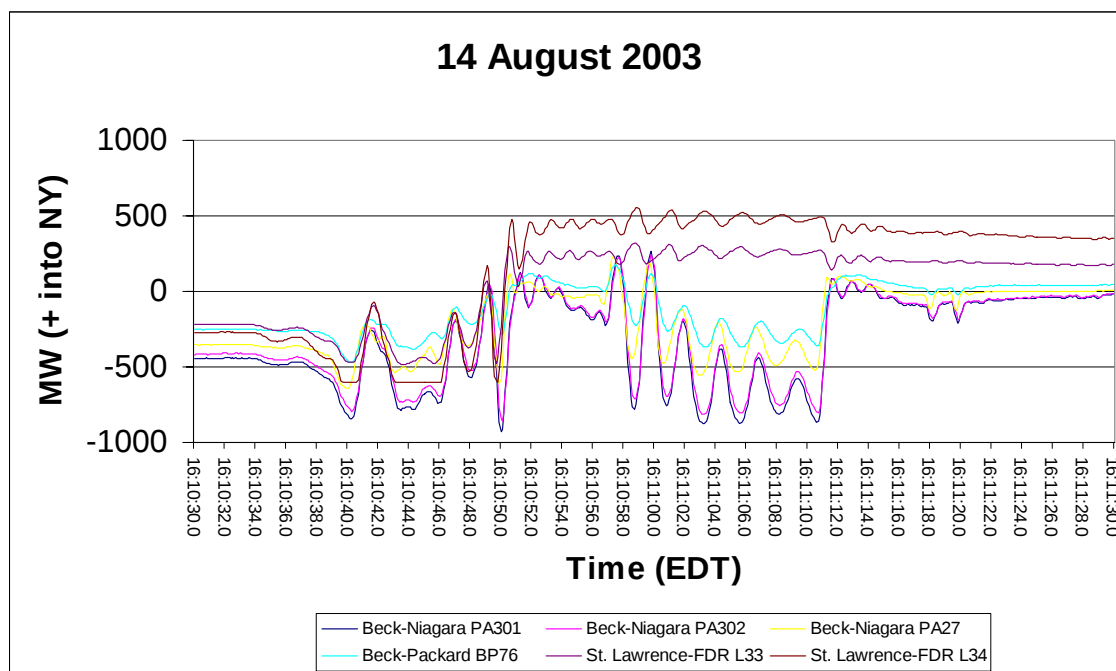
Figure 2.12

Transmission lines (3 circuits) between Middleport and Beck reclosed at 16:10:55, reconnecting the western New York island with the severely generation deficient southwest Ontario island (including Detroit Edison and what was left of FirstEnergy). The frequency declined rapidly to 58.5 Hz and the power oscillations (on the IMO-NY ties) returned. The rapid frequency decline initiated both stages of under-frequency load shedding in the western New York island, and 3,389 MW of load was disconnected by 16:11:15. The 3 Middleport – Beck circuits’ tripped and locked out at 16:11:10, and the western NY island frequency again rose toward 63.0 Hz.

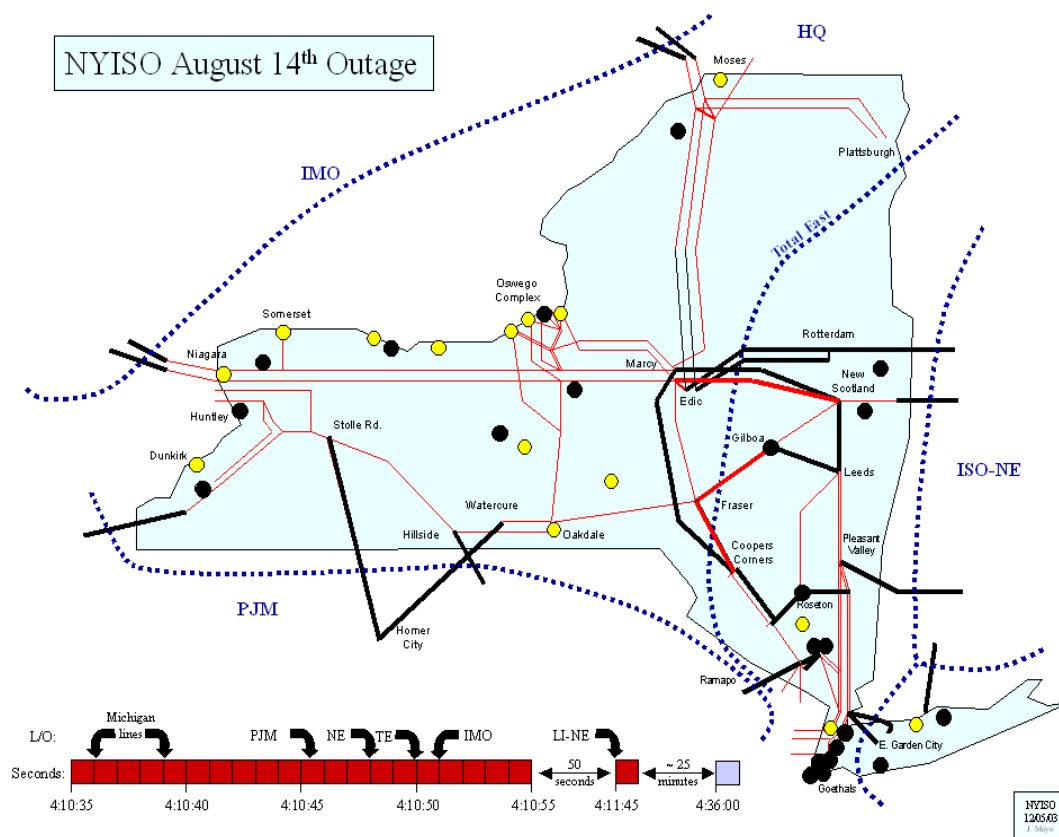
Figure 2.13

In the southeastern New York island, after separating from the west, the frequency declined toward 57 Hz. Due to the low frequency and low voltages, the nuclear units at Indian Point both tripped on low reactor coolant flow. The reactor trips were initiated at 16:10:51 and 16:10:54, respectively. Frequency in the southeastern New York was effectively in free fall. Over the next minute, many in-city generators tripped.

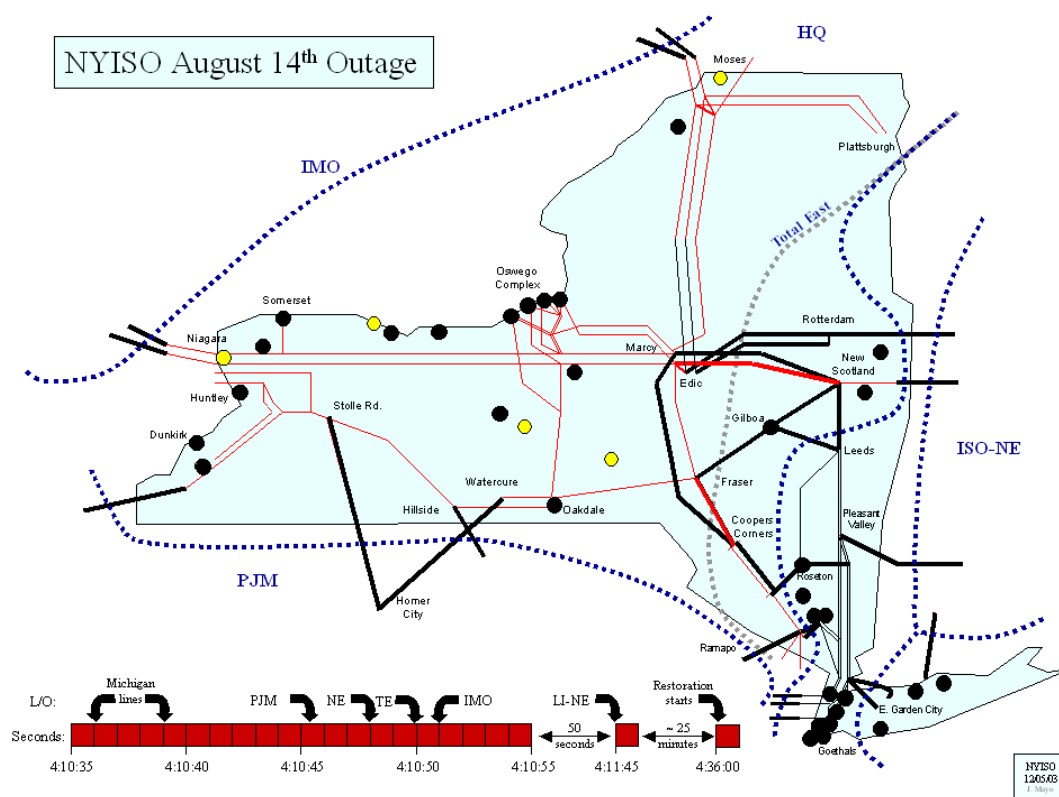
Figure 2.14

A major portion of the northern section of the Eastern Interconnection was blacked out. Some isolated areas of generation and load remained online for several minutes. Some of those areas in which a close generation-demand balance could be maintained remained operational; other generators ultimately tripped offline and the areas they served were blacked out.

At 16:08, just prior to the event, the NYISO was serving approximately 28,700 MW of load. Ten minutes later, the load was 5,716 MW, representing a loss of 22,984 MW. Automatic under-frequency load shedding disconnected a total of 10,648 MW statewide.

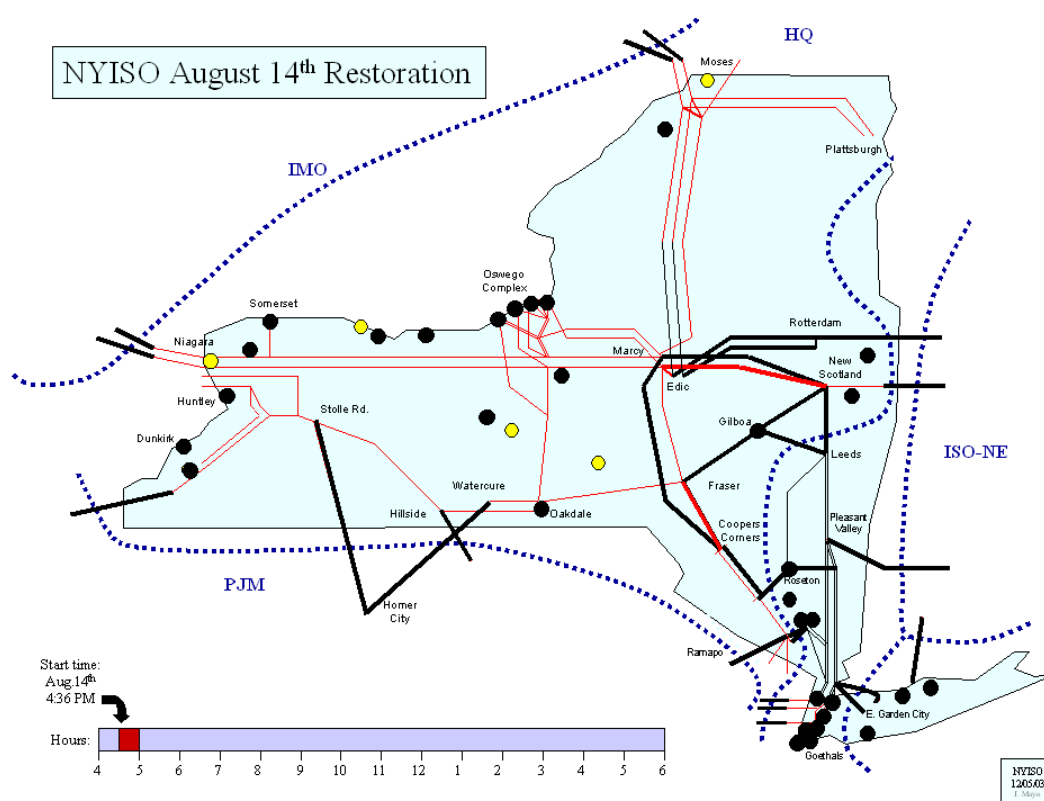
Figure 3.1

The NYCA transmission system was islanded and with radial interconnections at Niagara, St. Lawrence, and Waldwick stations. The bulk power transmission system was energized from Niagara station in the West, Massena station to the North, New Scotland station in the Capital area, Ramapo station in the Hudson Valley, and Oakdale station in the Central LBMP zone. The western island remained relatively stable and was able to serve about 5,700 MW of load in western New York and in the Albany and Schenectady area following the event. Generation at the Beck and Niagara, Saunders and St. Lawrence, some thermal generation in western New York, and the HVdc intertie with Quebec formed the basis for restoration of both the New York and Ontario systems.

There were large frequency and voltage deviations during the initial islanded period as generation and load imbalances were encountered.

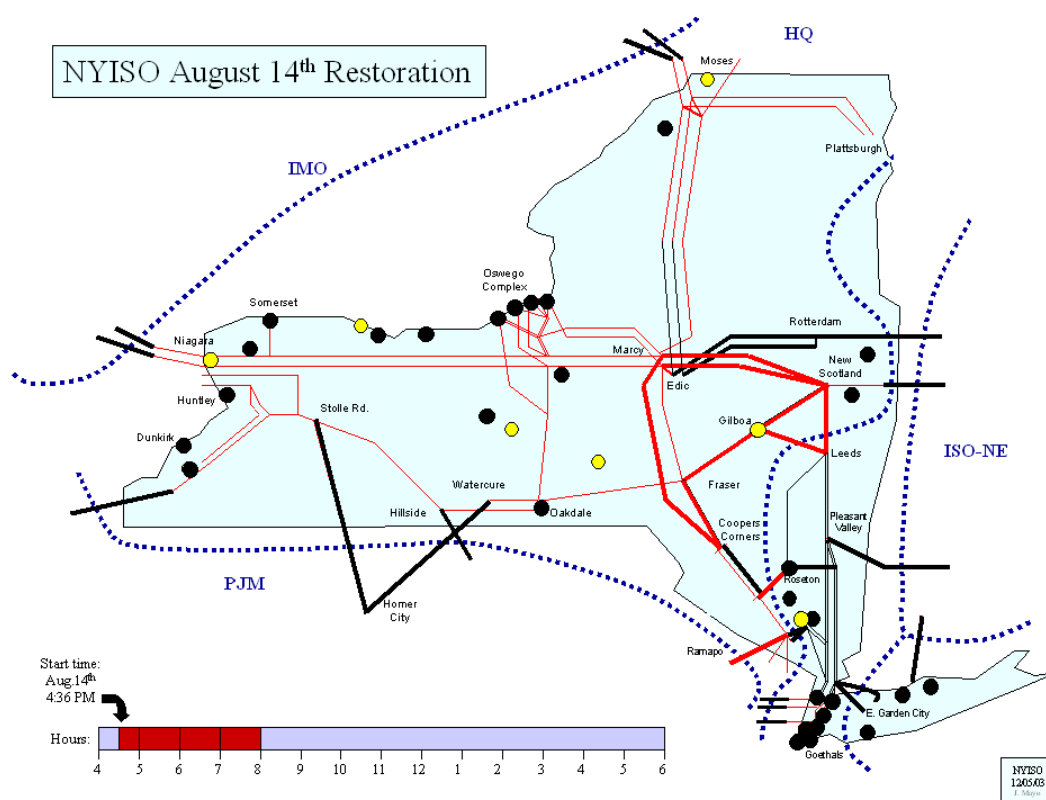
Figure 3.2

At 16:27, the NYISO ordered Gilboa to start its Black Start procedures. The NYISO coordinated with the IMO about the Saunders and Beck generation, which were radially connected to the NYISO system. The NYISO confirmed with PJM that the Waldwick interconnections were still in service, supplying radial load in North New Jersey. At 17:15 over the Hotline, the NYISO reported to the TOs about the status of the bulk power system, and directed them to follow through with their local restoration plans and to coordinate anything affecting the bulk power system with the NYISO.

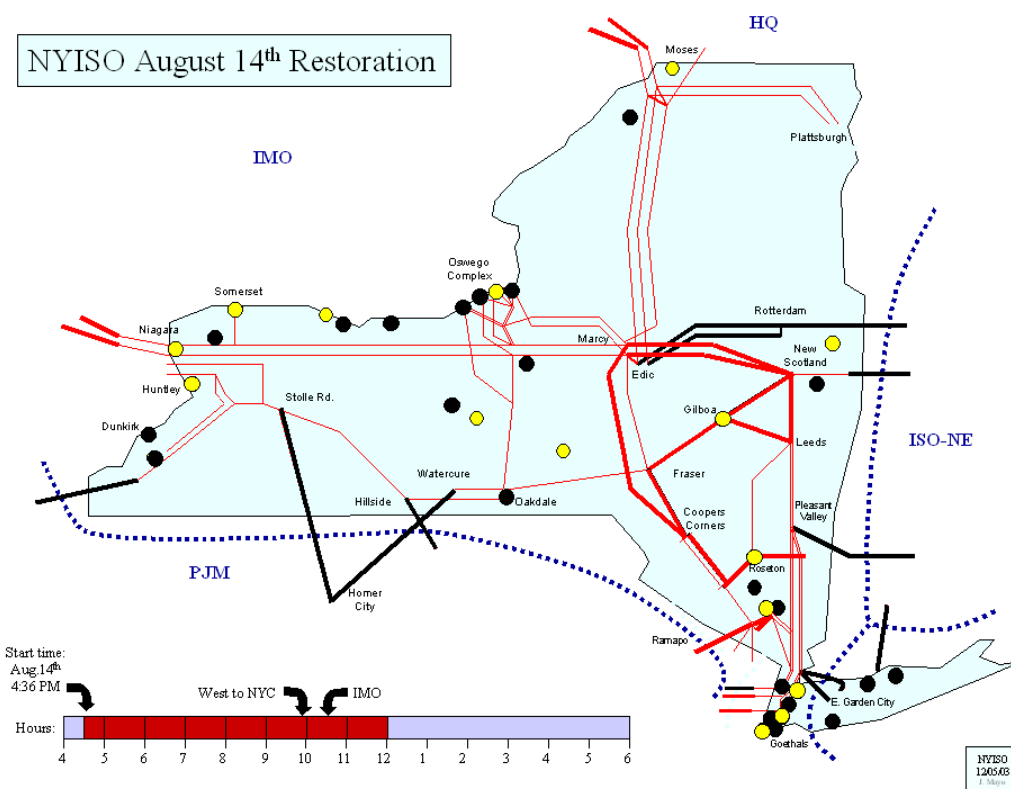
Figure 3.3

By 19:07, with New York resynchronized with PJM at Ramapo, the process to extend the now stabilized system into the blacked-out southern island was well underway. At 19:56, a Southeast transmission corridor from Buchanan to Eastview (W93) and from Eastview to Sprain Brook (W79) was energized to Sprain Brook station and cranking power was available to Astoria East station, as well as load restoration at 179ST station.

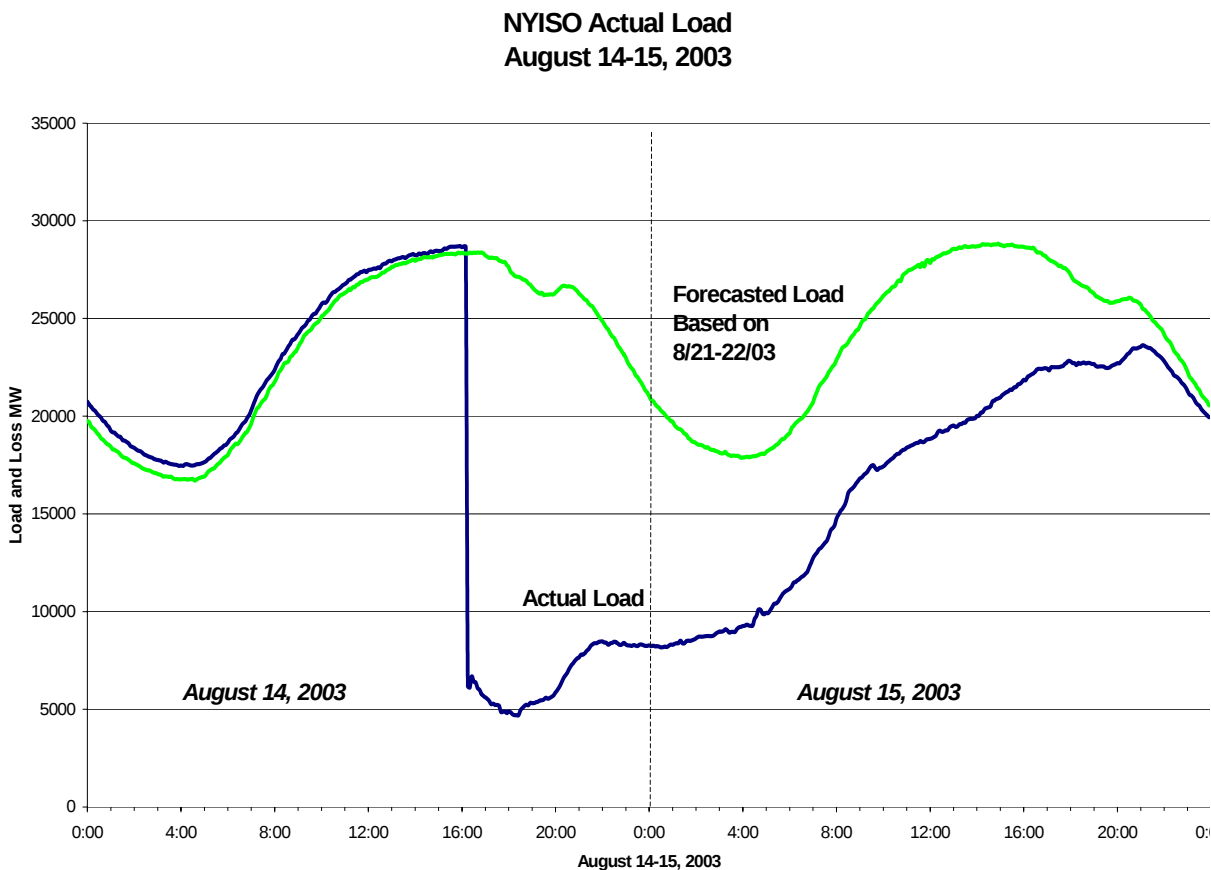
Figure 3.4

At midnight on August 15th, approximately 40% of the load had been restored to the NYISO system. The NYISO and PJM continued to restore the remainder of the interconnections between the two control areas.

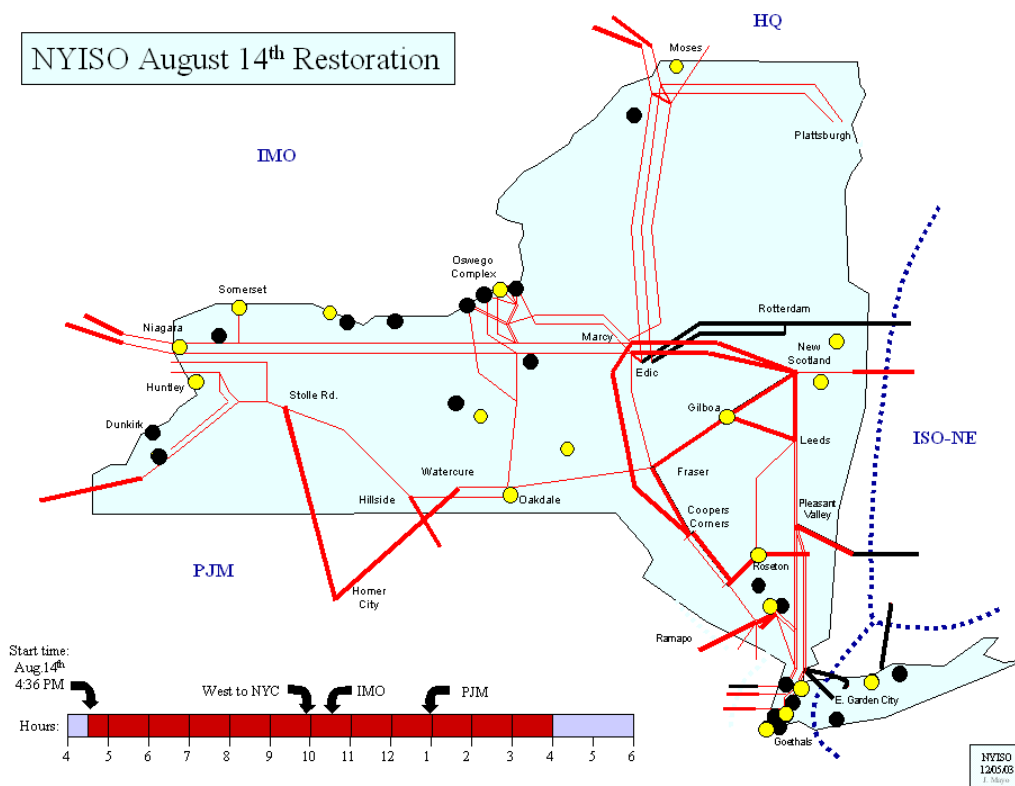
Figure 3.5

The New England control area was reconnected to New York and thus, to the Eastern Interconnection at 01:53 EDT on Friday, August 15th.

The transmission grid was extended from Northeast (New Scotland 345 kV) into ISO-NE by an express feeder through Alps and Berkshire into ISO-NE's Northfield substation. The NYISO and ISO-NE coordinated the synchronization of the New England transmission system to the NYCA transmission system, via synchroscope operation at Northfield, to restore normal frequency control for ISO-NE.

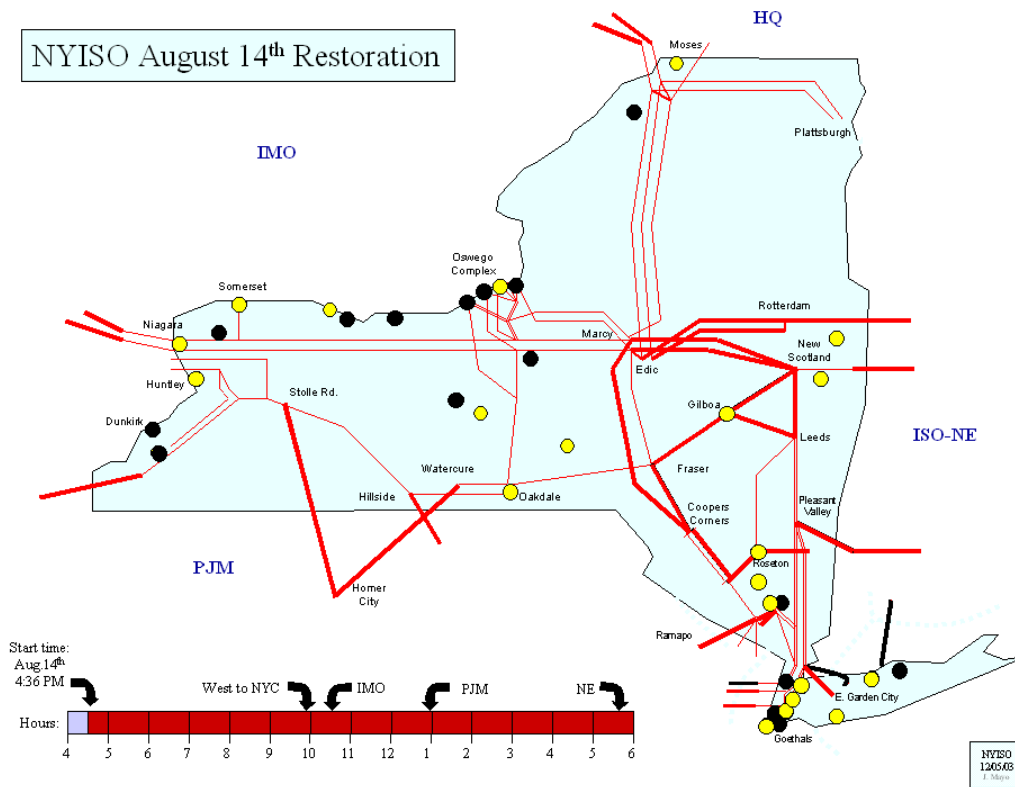
Figure 3.6

At 12:26, the Cross Sound Cable went in service, allowing an additional 100 MW of emergency energy to flow from ISO-NE to Long Island.
